Virginia Department of Forestry BMP Effort, Implementation, and Effectiveness Field Audit

•
November 2000

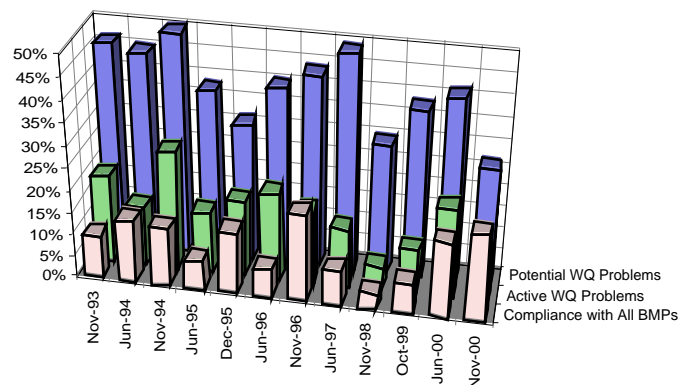
Fig. 5: Three Trends

Efforts to implement BMPs were evident at 97% of inspected timber harvests, no change from the 97% recorded in June 2000, (*fig.1*). Quality of effort, rated on a scale of 1(poor) to 5(excellent), averaged 3.1; up from an average of 2.7 in June 2000. Implementation of all necessary BMPs to DOF standards occurred at 20% of inspected sites;

up from a 17% BMP implementation rate recorded in June 2000, (*fig. 2*).

Active water quality problems exist at 10% of inspected sites; down from 21% in June 2000, (*fig. 3*). Potential water quality problems were noted at 27% of the inspected sites; down from 41% in June 2000, (*fig. 4*).
